NBSIR 82-2465

Investigation of the Kansas City Hyatt Regency Walkways Collapse

February 1982

**INVESTIGATION OF THE KANSAS CITY
HYATT REGENCY WALKWAYS COLLAPSE**

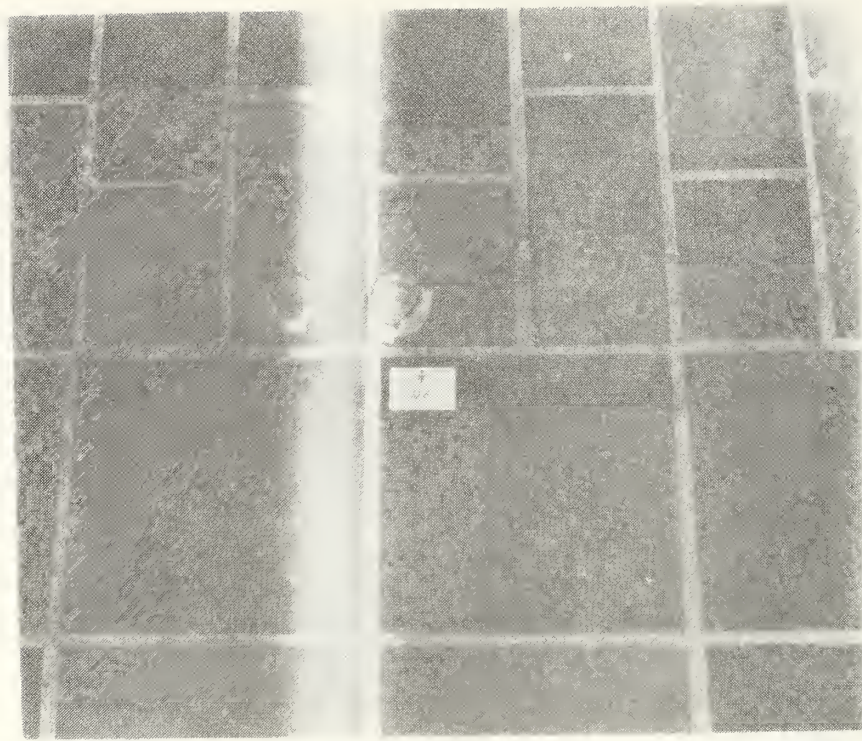
Figure 5.3 Tile damage caused by second floor hanger rod 10E.

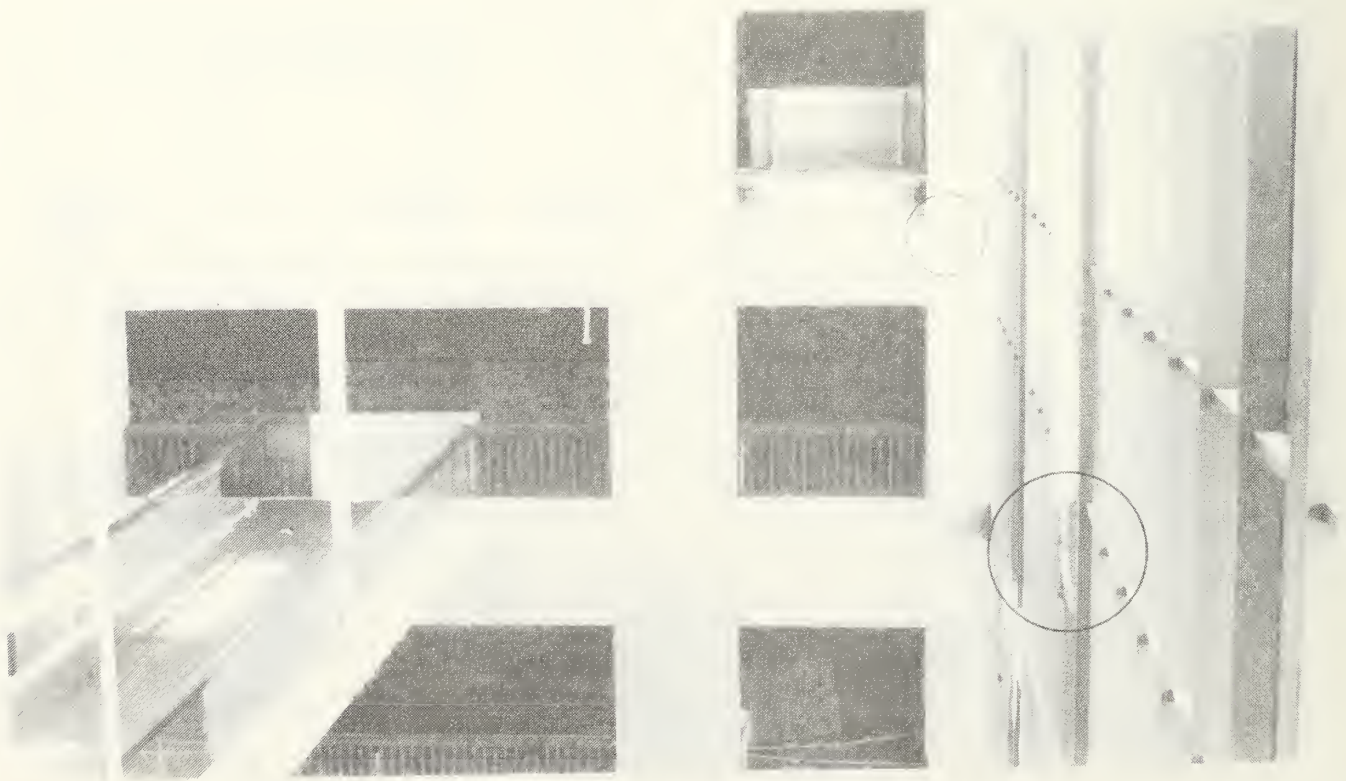
One final observation of importance is the pronounced bend to the west at the bottom end of hanger rod 10UW and a lesser bend at the bottom of hanger rod 8UW as can be seen in figure 5.4. Not apparent in figure 5.4 is a slight bend at the bottom of hanger rod 9UW which was detected after the hanger rods had been removed to the warehouse. The absence of appreciable distortions in hanger rods 8UE, 9UE, and 10UE strongly suggests that failure initiated along the east line of hanger rods.

Figure 5.4 Fourth floor to ceiling hanger rods. View from fourth floor looking south.

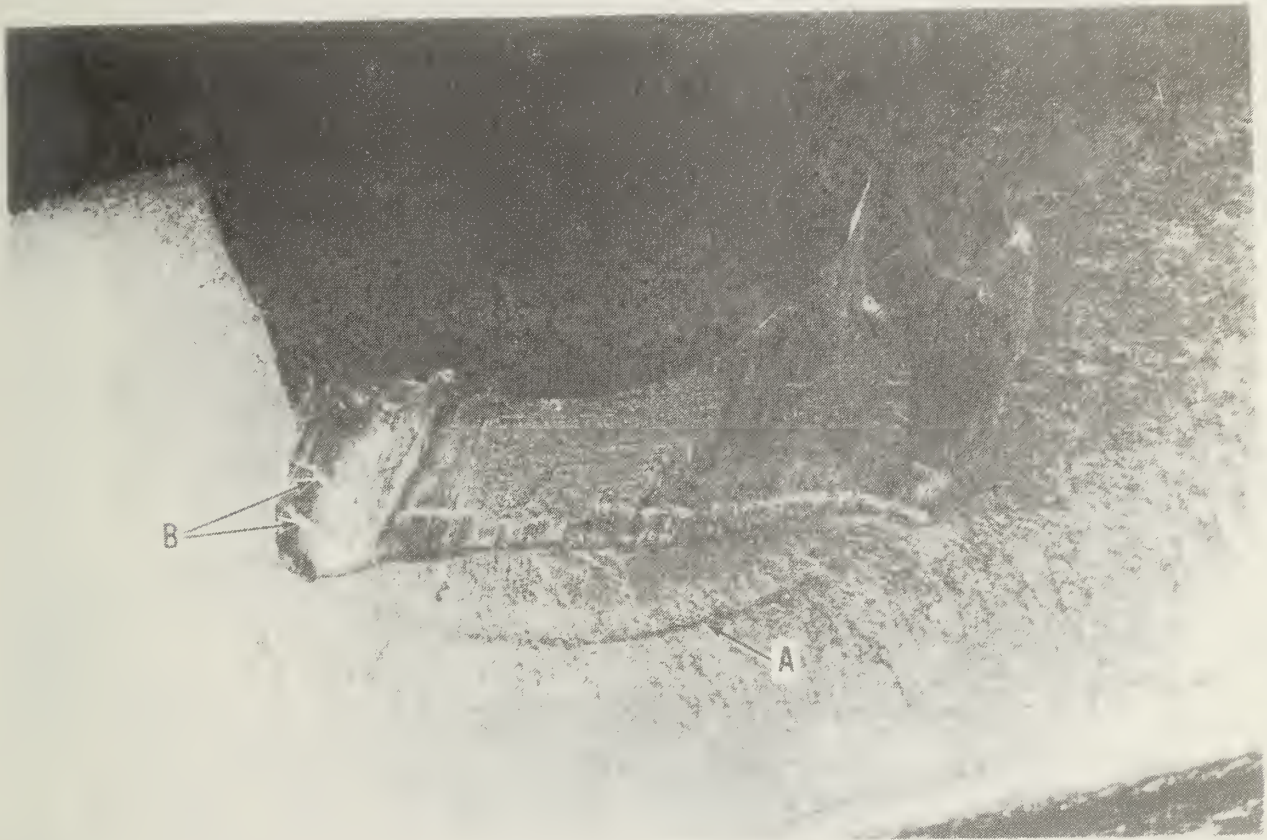
Figure 5.10 Deformation at underside, outer hole, location 9UE due to pull-through of washer/nut assembly. Note imprint of washer (A) and evidence of slip-stick progressive failure (B).

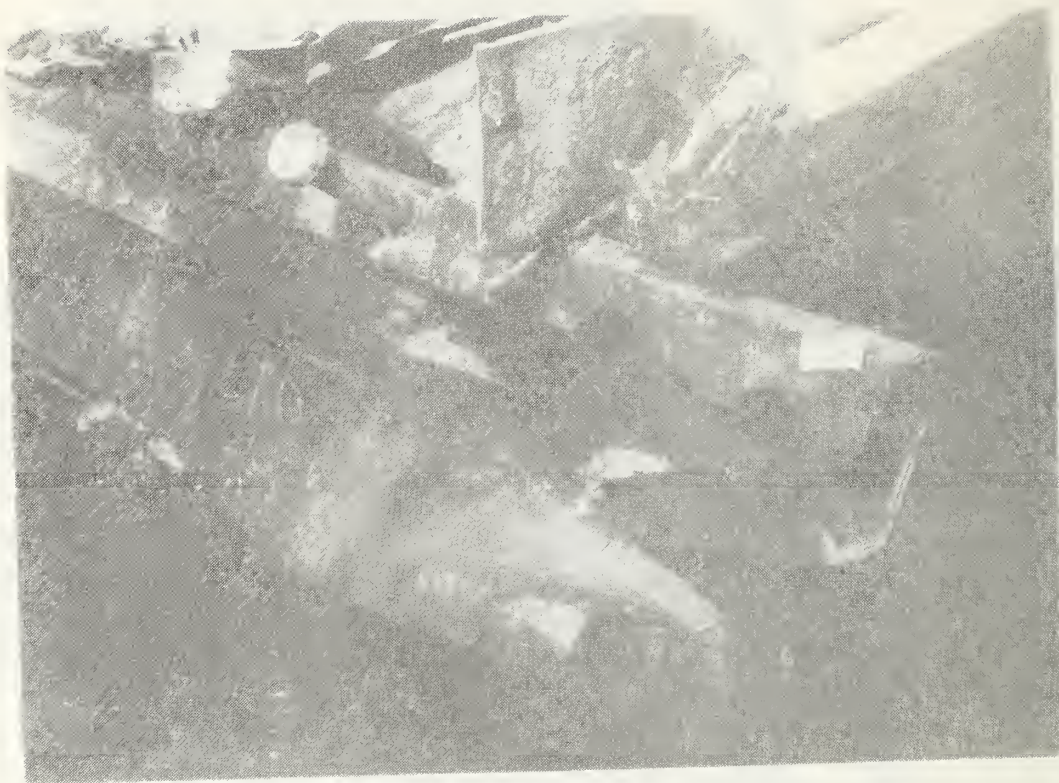
Figure 5.11 Box beam at location 10UW (Span U9-10).

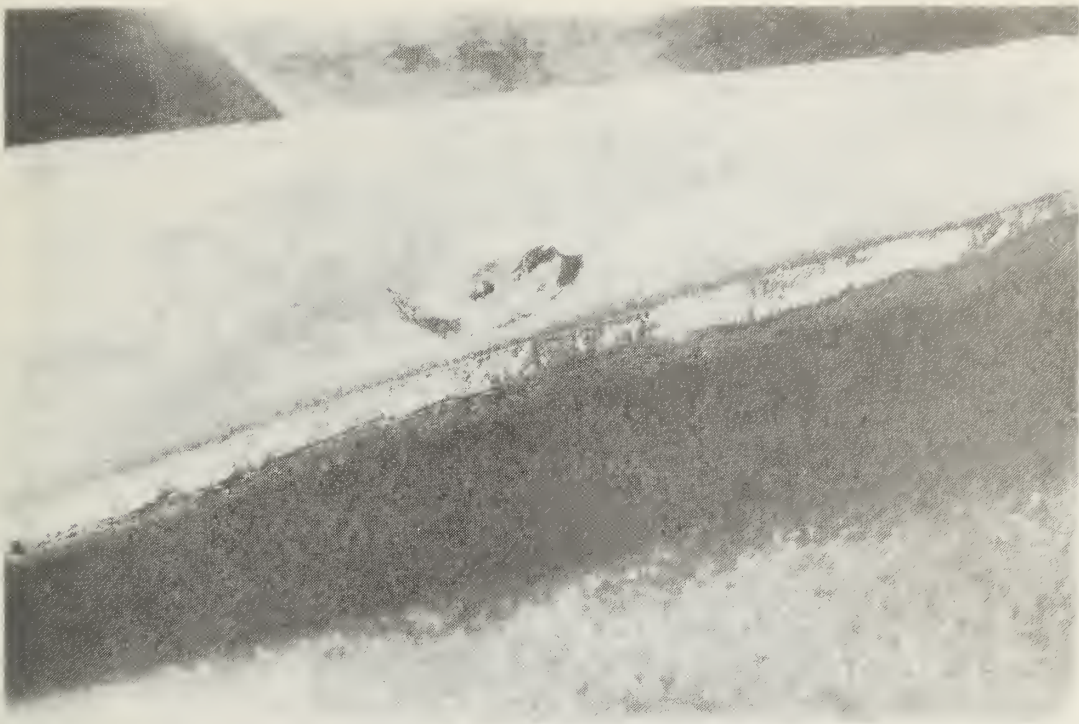
Figure 5.15 Weld penetration at location 8UW, upper flange.

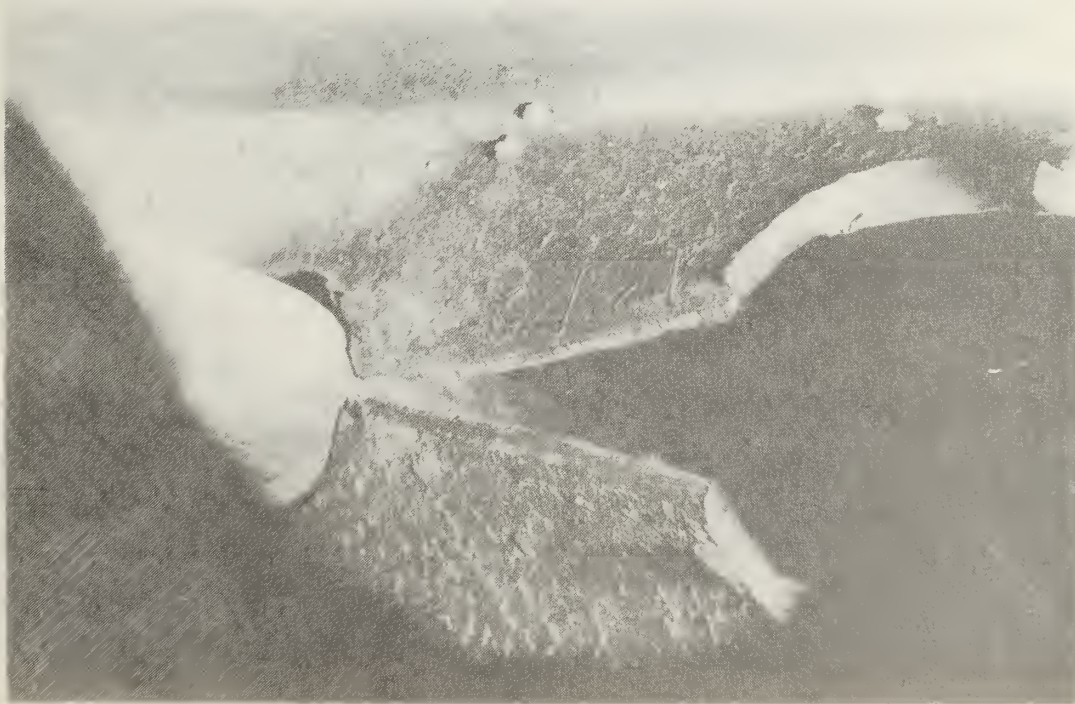
Figure 5.16 Fracture through the weld at location 9UE, lower flange.
Weld porosity denoted by arrows.

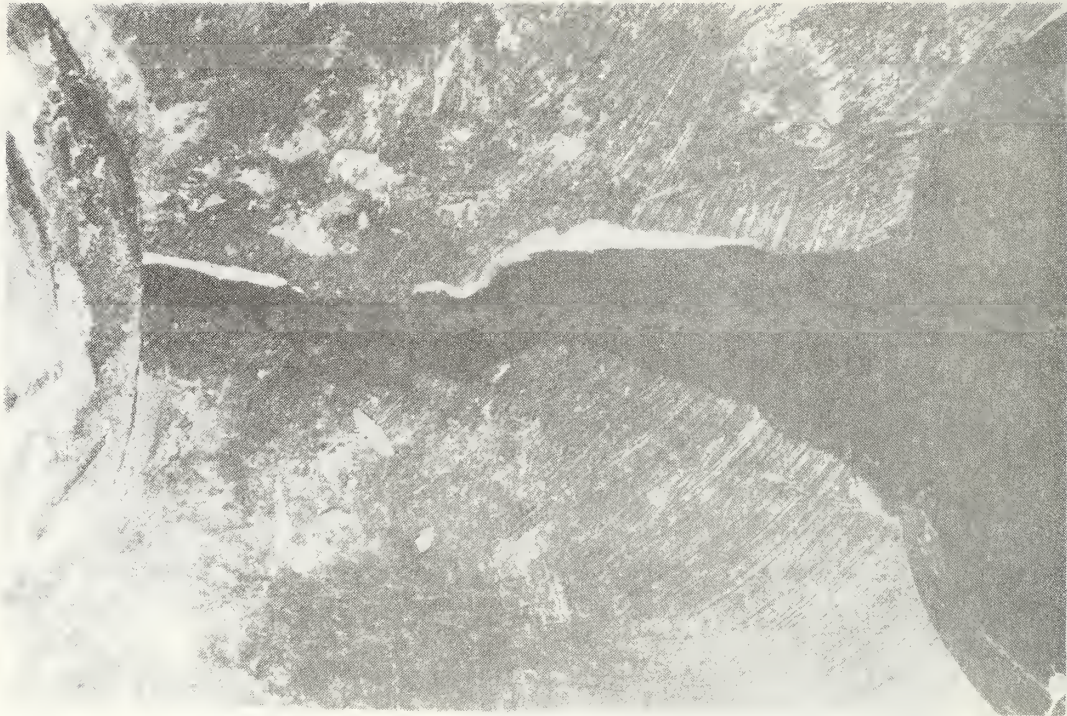
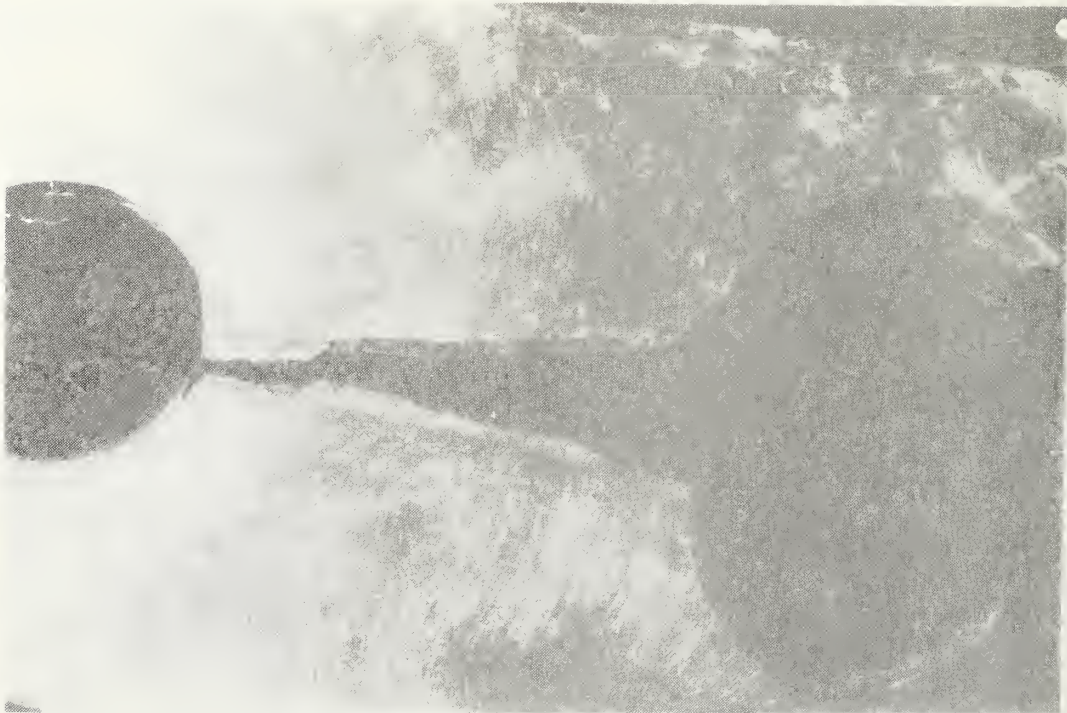
Figure 5.17 Fusion line weld fractures between hanger rod holes, upper flange weld, locations 9UE(a) and 8UE(b).

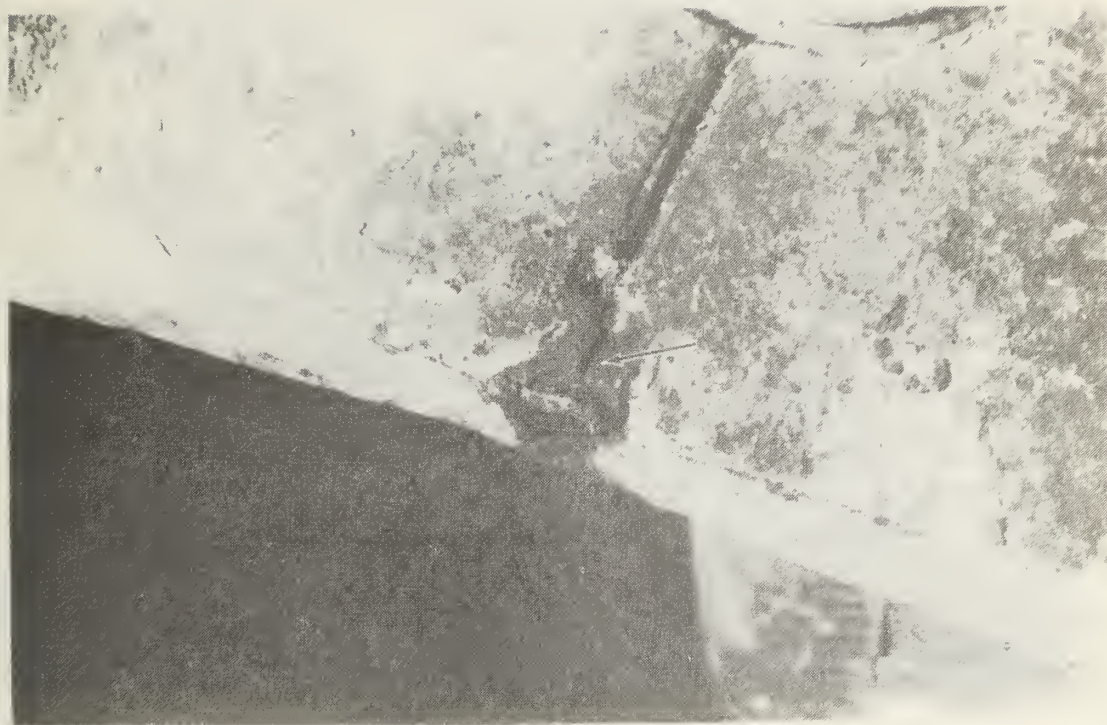
a) Location 8MW. Tack weld crack.

Figure 5.18 Apparent cracks (arrows) in lower welds of box beams in third floor walkway.

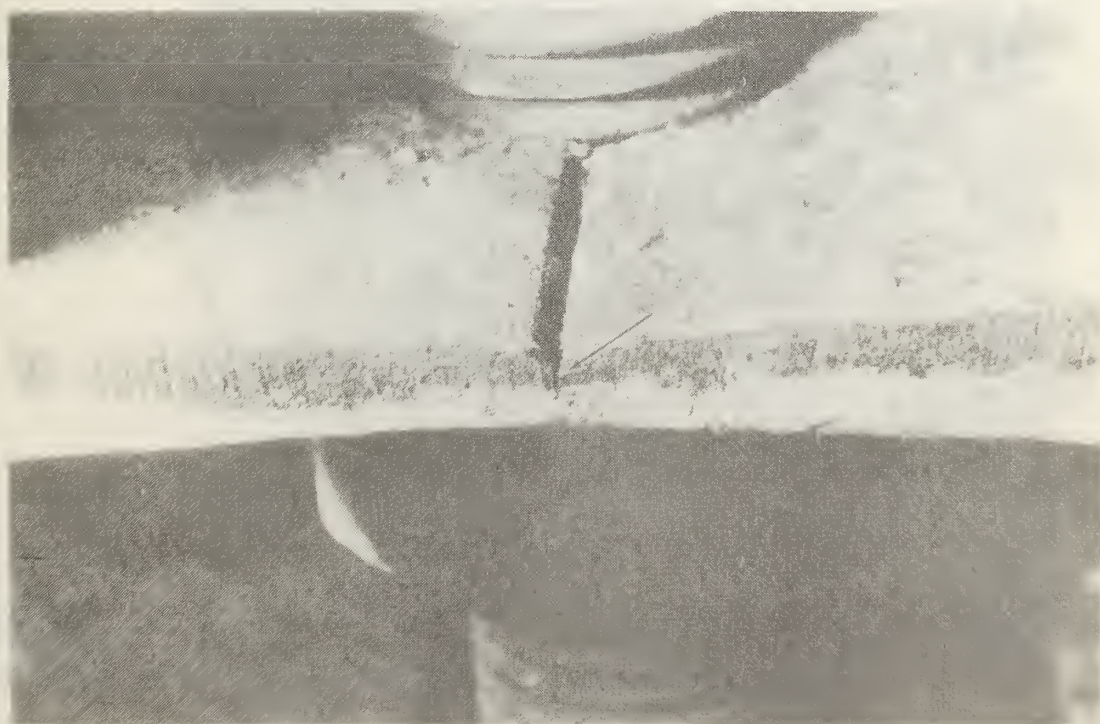
b) Location 8ME. End crack.

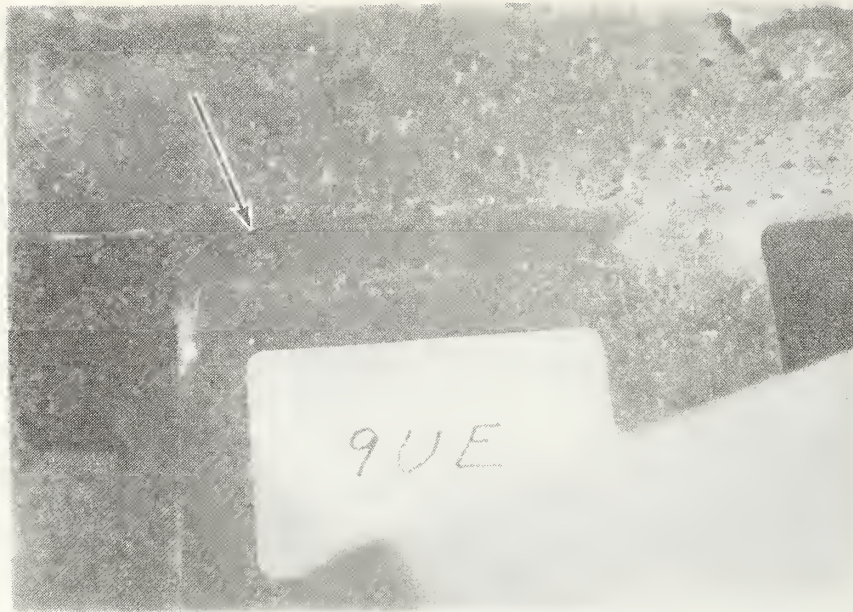
Figure 5.19 Incipient shear failure, bottom fillet weld of intact clip angle, location 9UE, south side.

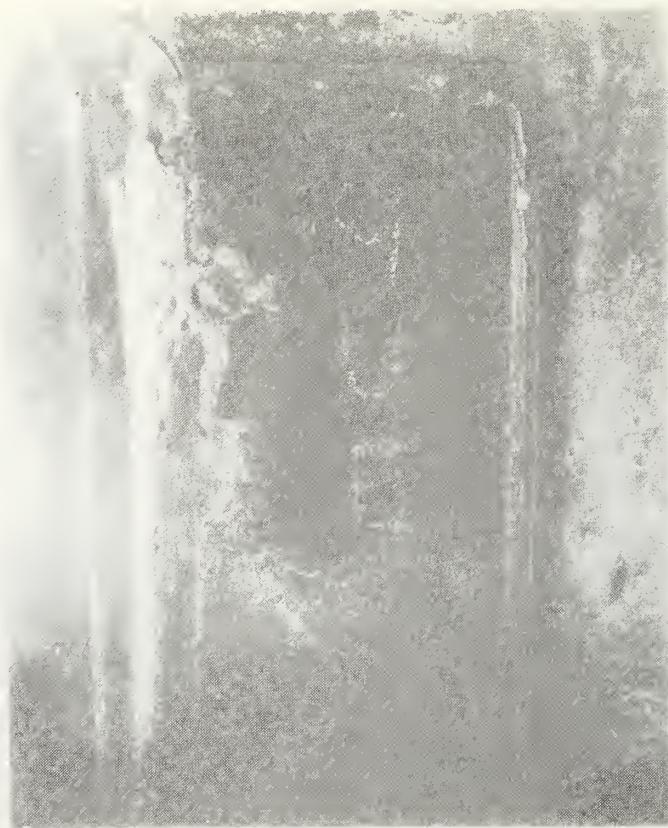
Figure 5.20 Shear failure at bottom and pull-out failure at top of clip angle, location 9UE, north side.

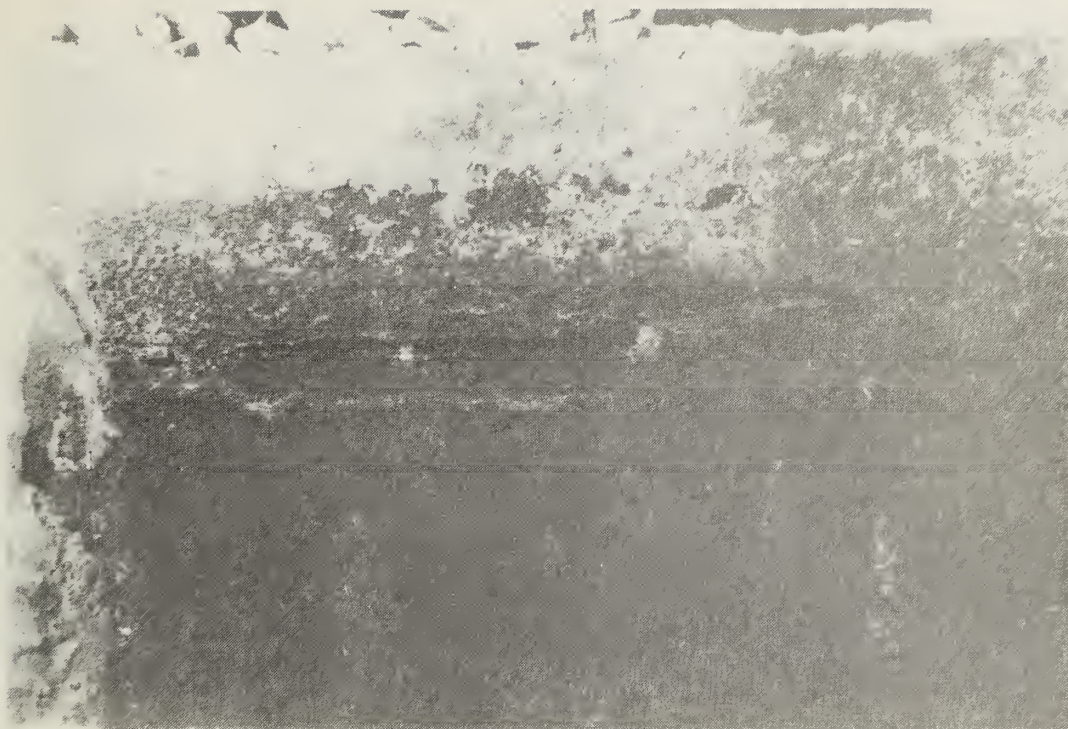
Figure 5.21 Pull-out failure of top fillet weld on box beam web, location 9UE, north side.

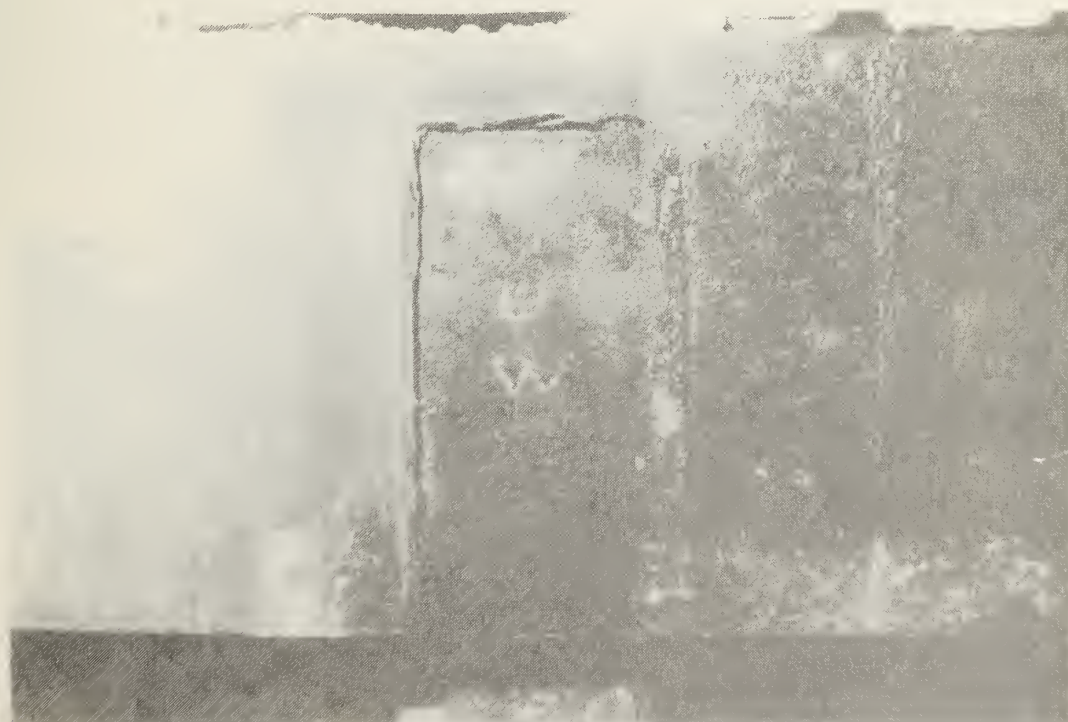
Figure 5.22 Shear failure in clip angle fillet weld at location 9UW, north side. This weld and the corresponding weld at location 9LW did not show evidence of a pull-out (tensile) failure at the top fillet weld.

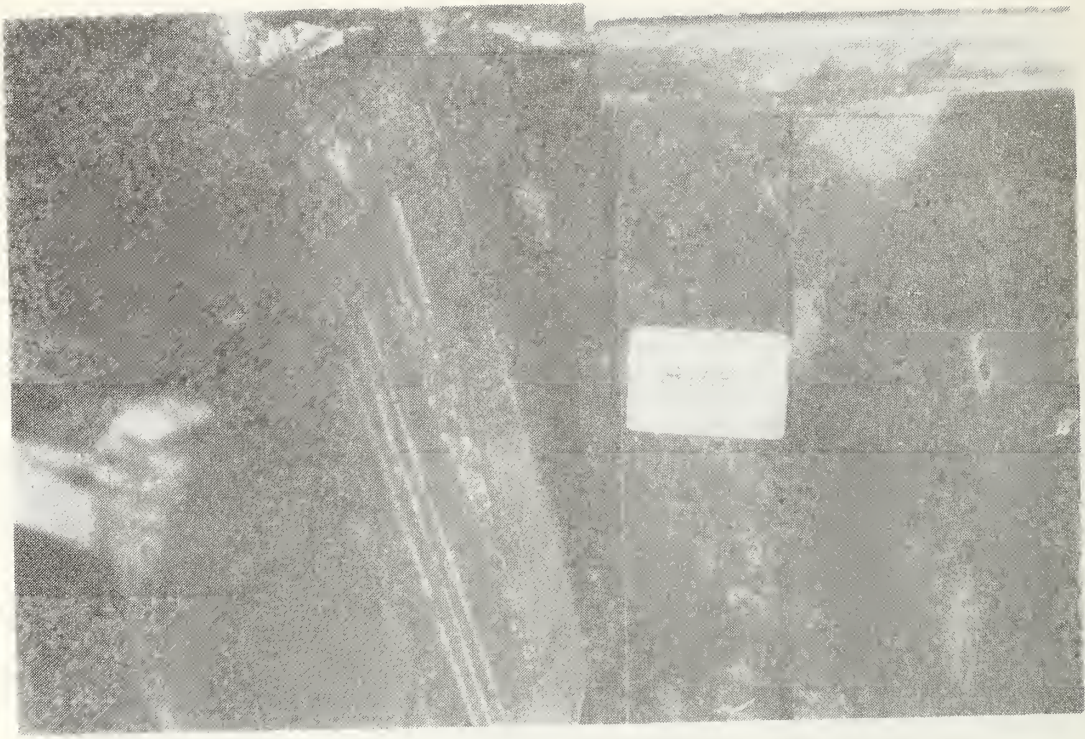
Figure 5.23 Tearing of top end of north clip angle at location 8UE.

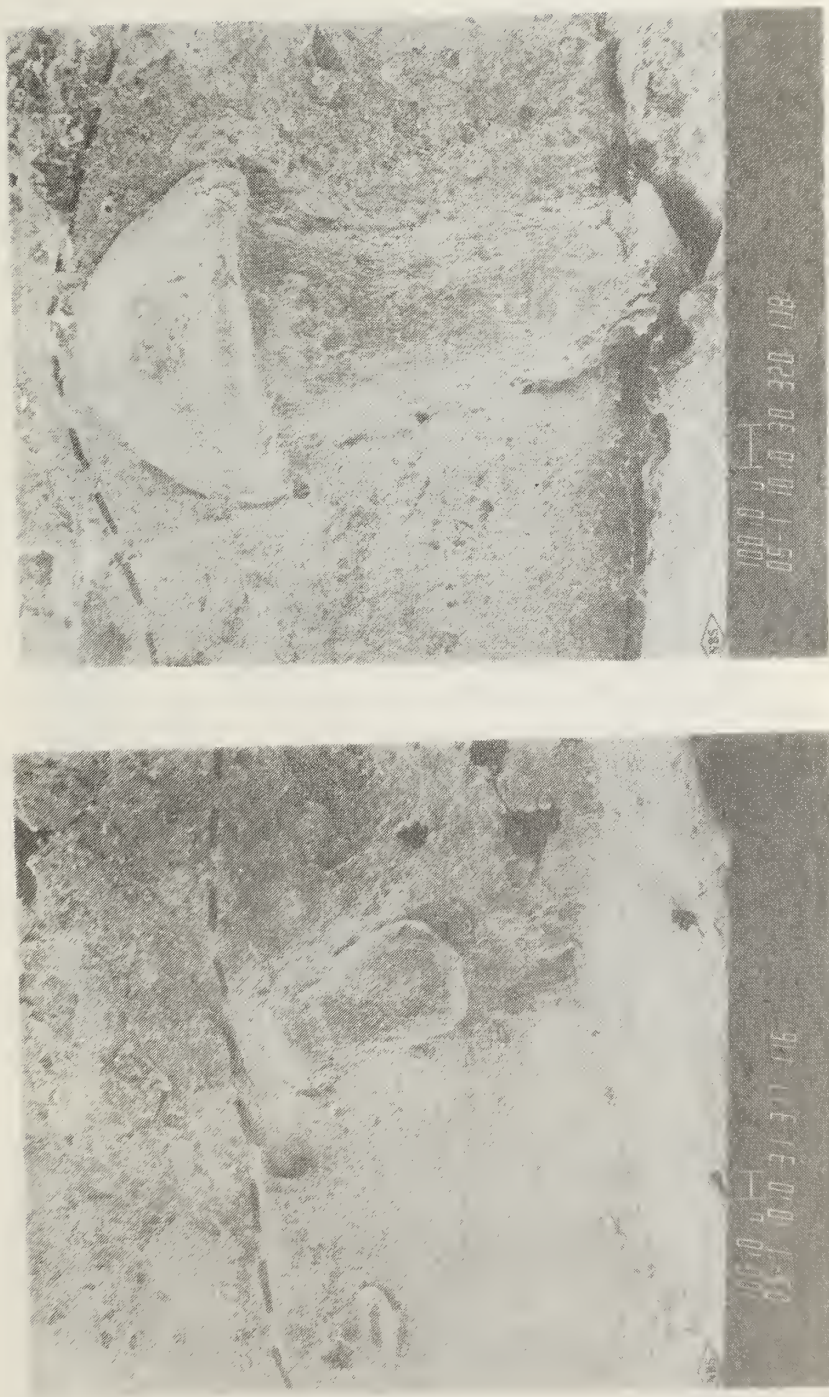
Figure 8.3 Photomicrographs showing that the crack initiated at the root of the weld and propagated to the exterior of the box beam (location 9UE). Figure (a) is located 3 mm from the end of the beam. Crack is propagating downward and slightly to the right. Figure (b) is located 18 mm from end of beam. Magnification (a) X30 and (b) X60.

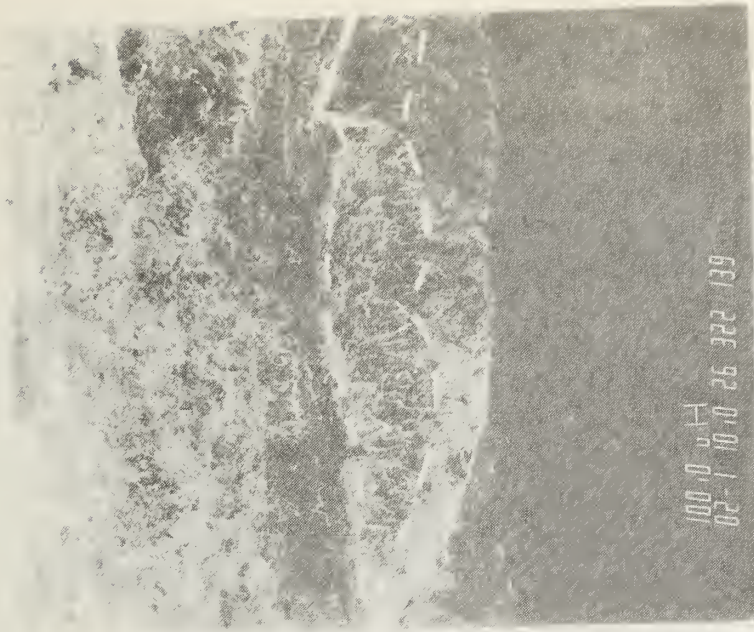
Figure 8.5 Fractographic evidence of preexisting cracks in walkway box beam exterior longitudinal welds at locations a) 9UW, b) 9UE, c) 8UW. Regions interpreted as cracks outlined by dashed lines. Magnifications X55, X250 and X25, respectively.

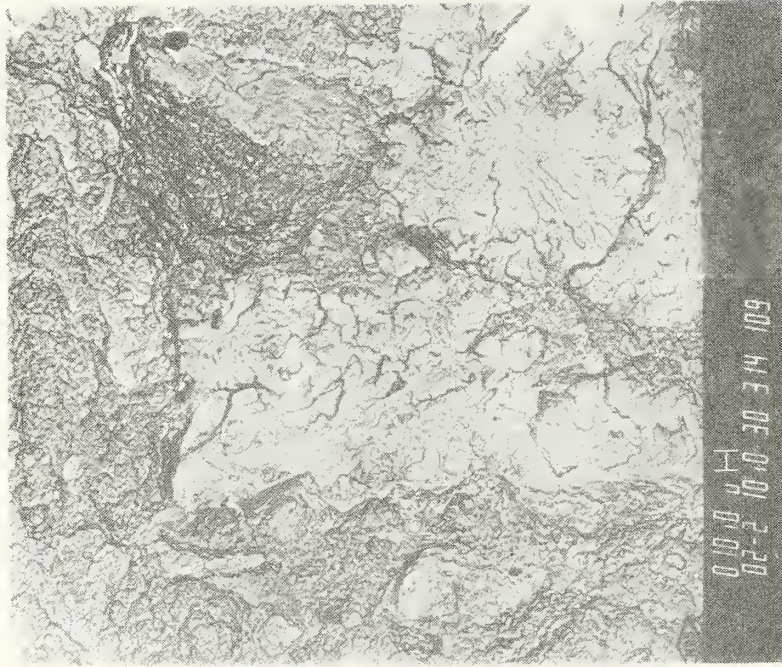
Figure 8.7 Cleavage facets observed at center line of lower exterior longitudinal weld at location 9UW (bright areas). Magnification X250.

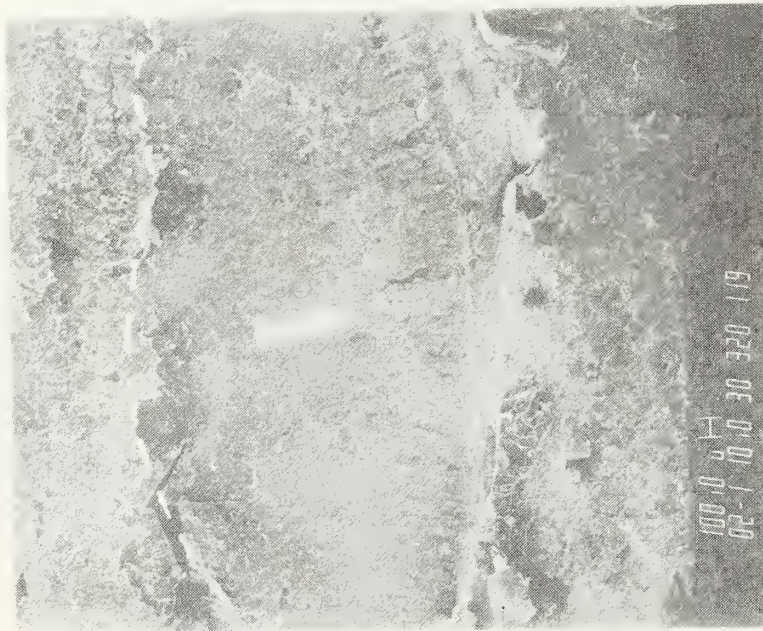
Figure 8.6 Evidence of fracture initiation from upper surface of interior tack weld (dashed line) at location 9UE. Direction of propagation is toward the weld root (arrow) normal to the welding direction. Magnification X25.

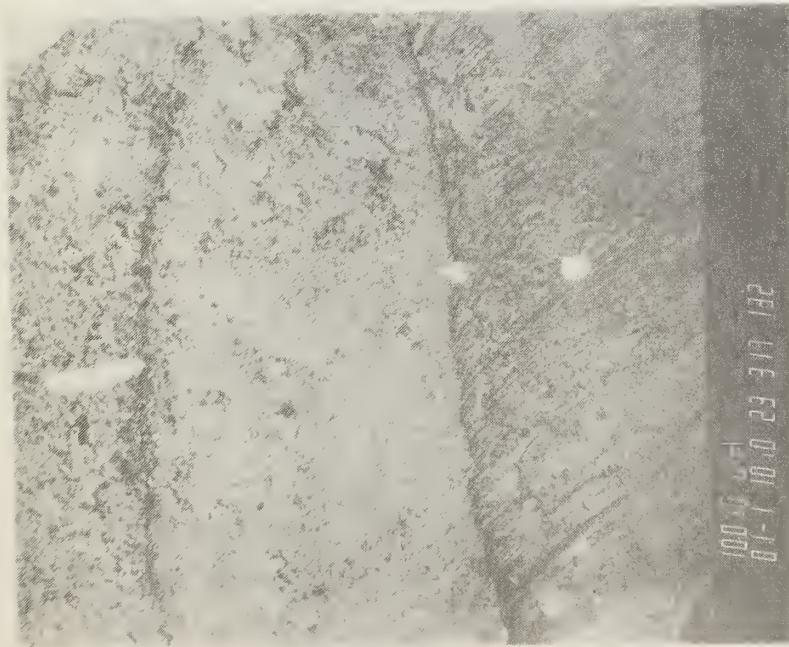
7. Two regions of washer imprints were observed on the bottom surfaces of the box beam flanges. The outermost region contains the imprint of the washer and shows shallow striations. Nearer the hanger rod hole, there was a transition to a more deeply abraded region. This region showed evidence that the failure proceeded in a slip-stick manner.

Figure 8.8 Abrasion pattern on bottom flange at location 9UE (north). Arrow denotes initial washer imprint. (A) denotes change in abrasion mechanism. (B) denotes a slip-stick region in progressive failure. Magnification X15.

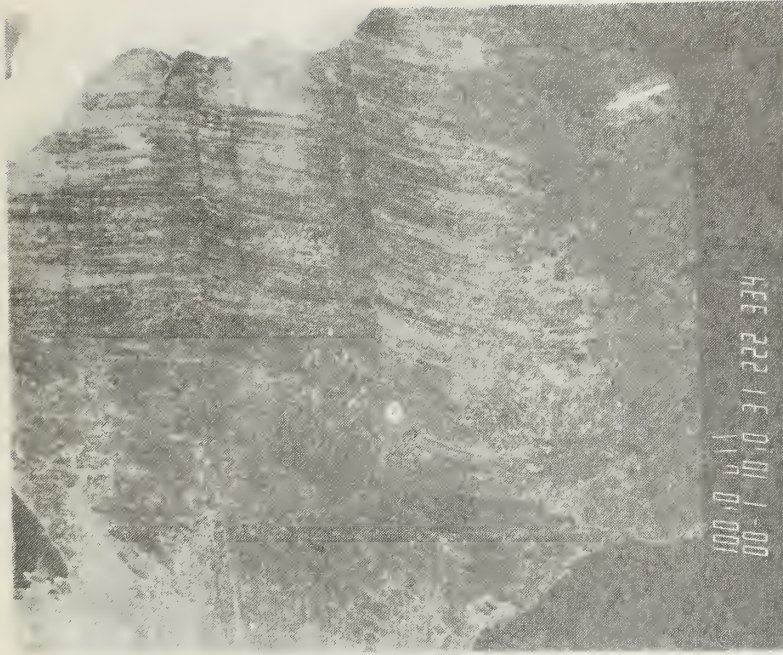
Figure 8.9 Abrasion pattern on bottom flange at location 10UE (south) showing multiple slip-stick regions. Arrow denotes initial washer contact. Magnification X15.

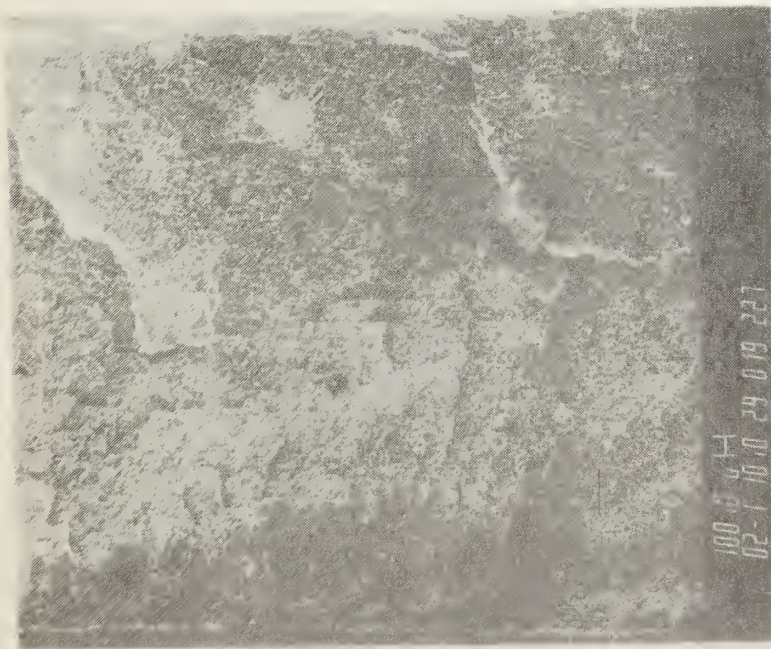
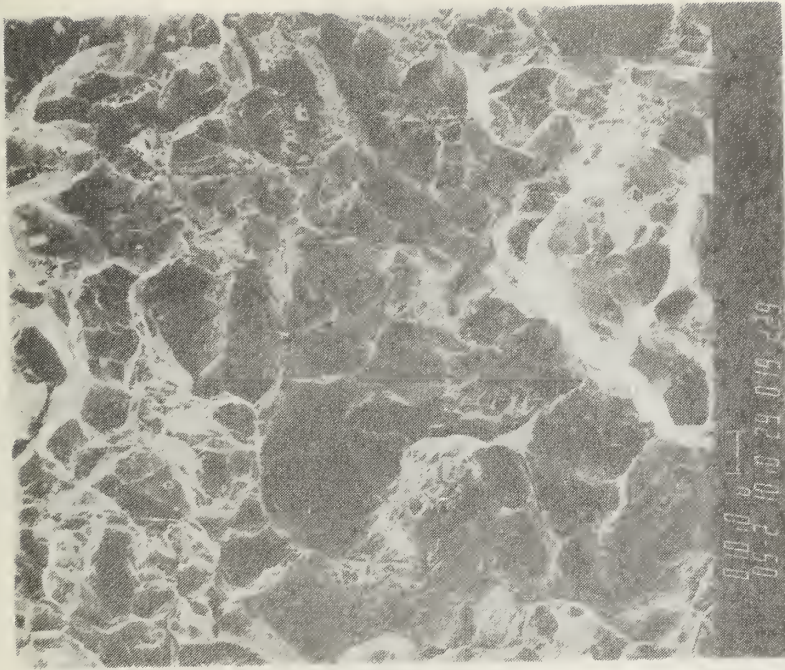
Figure 8.13 Fractographic appearance of walkway washer from upper end of hanger rod at location 9UE (NBS 11B) broken at NBS. Lower magnification view (a) shows no prominent MnS inclusions. Higher magnification view of center portion (b) shows essentially brittle intergranular fracture with a small amount of ductile rupture. Magnification (a) X25, (b) X550.

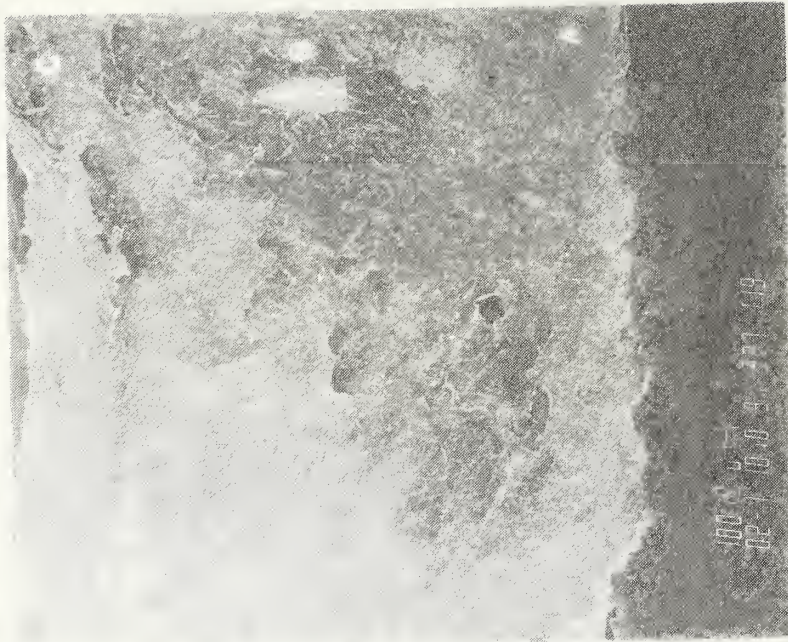
Figure 8.16 Fracture at top fillet weld at clip angle attachment, location 9UE (north). Initiation at A, propagation in direction B to shear lip at C. Magnification X25.

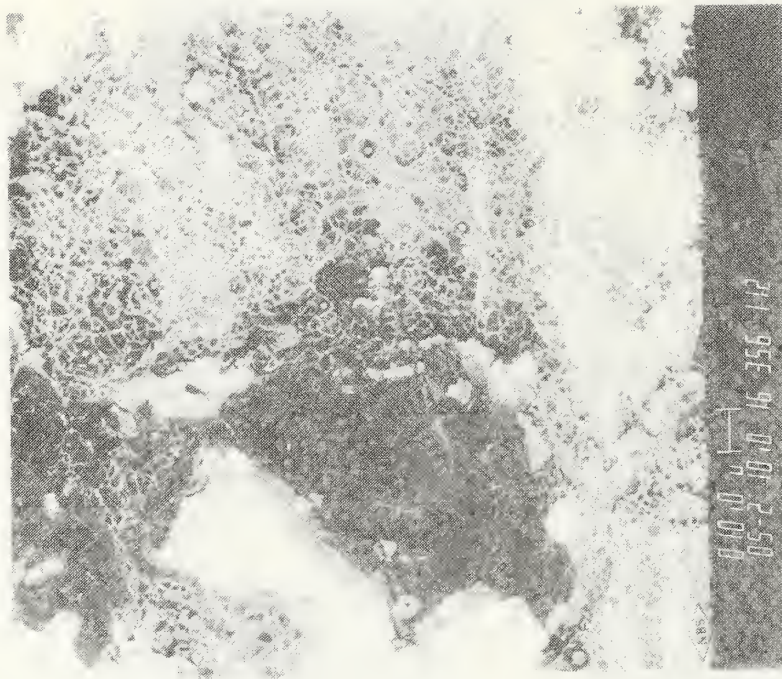
Figure 8.22 Fracture appearance in the preexisting crack region (a) and in the region of final crack propagation (b) at location 9UE adjacent to the outer hanger rod hole. Magnification X550.
